INVENTORY FORM FOR STATE HISTORIC SITES SURVEY

Tarbutton Mill House

Tarbutton Mill Rd., 1 mile S.E. of Rt. 50 (south)

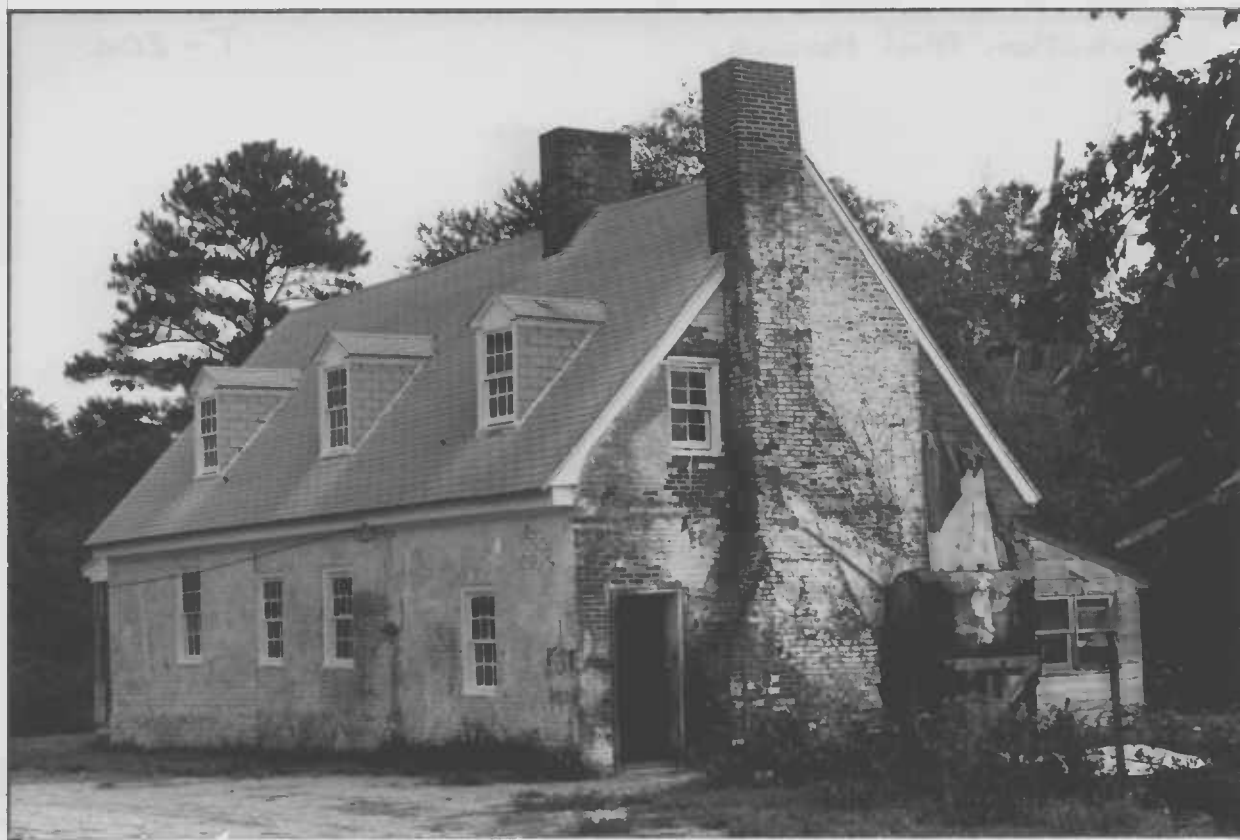
Tarbutton Mill House

On the east side of the building is a leanto addition of twentieth century date, incorporating an earlier porch. The south gable has an external assymetrical chimney and a partially framed wall.

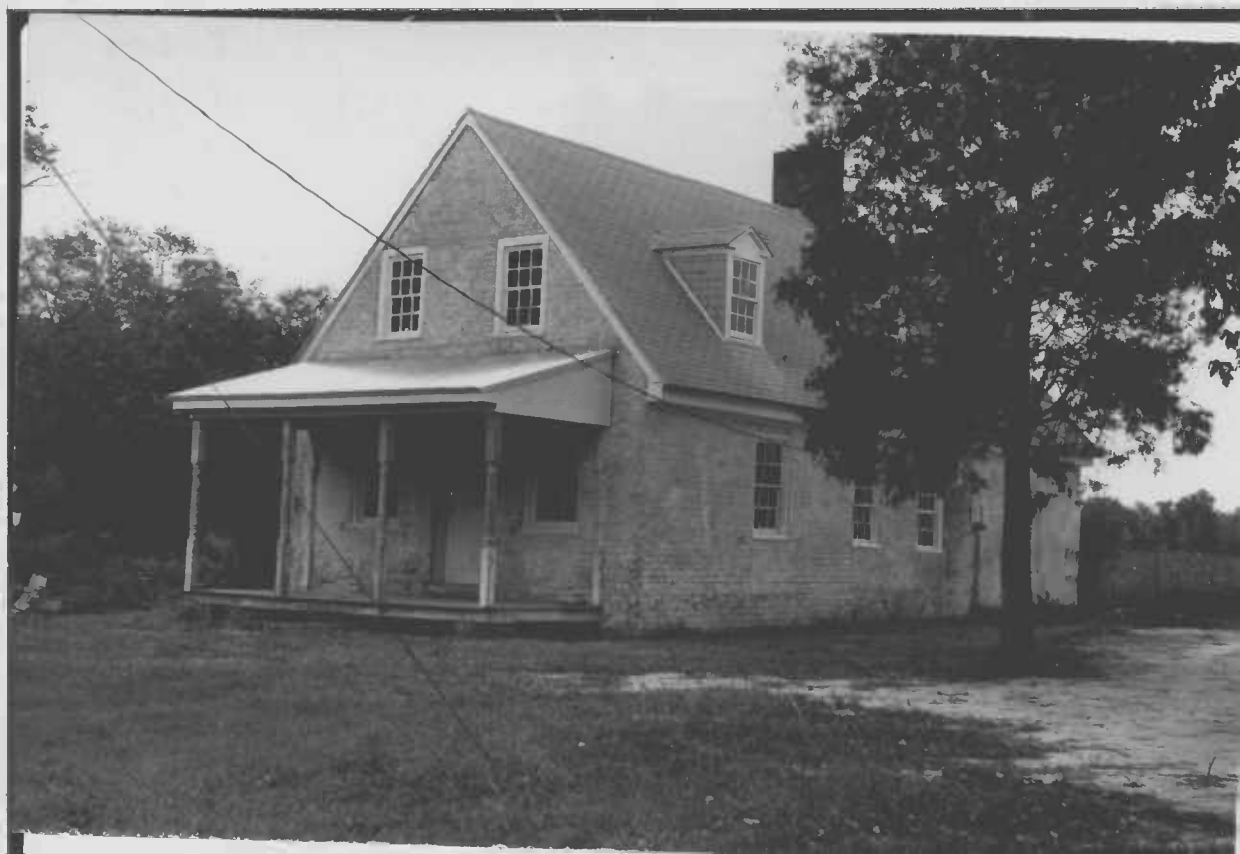
Tarbutton Mill House

The building is four bays long and two bays wide, with the principal entrance on the gable facade. The walls are laid in Common bond with headers every third row. Adjacent the second window from the north, and corresponding to it on the opposite wall, is a vertical seam indicating that the northern portion of the building is the earliest part.

The north facade is covered with a porch of twentieth century date. A center door is flanked by two large windows. Two windows light the attic above. All sash have 6/6 panes. The door opening has been reduced in size and the window frames replaced, although those on the second floor appear original.

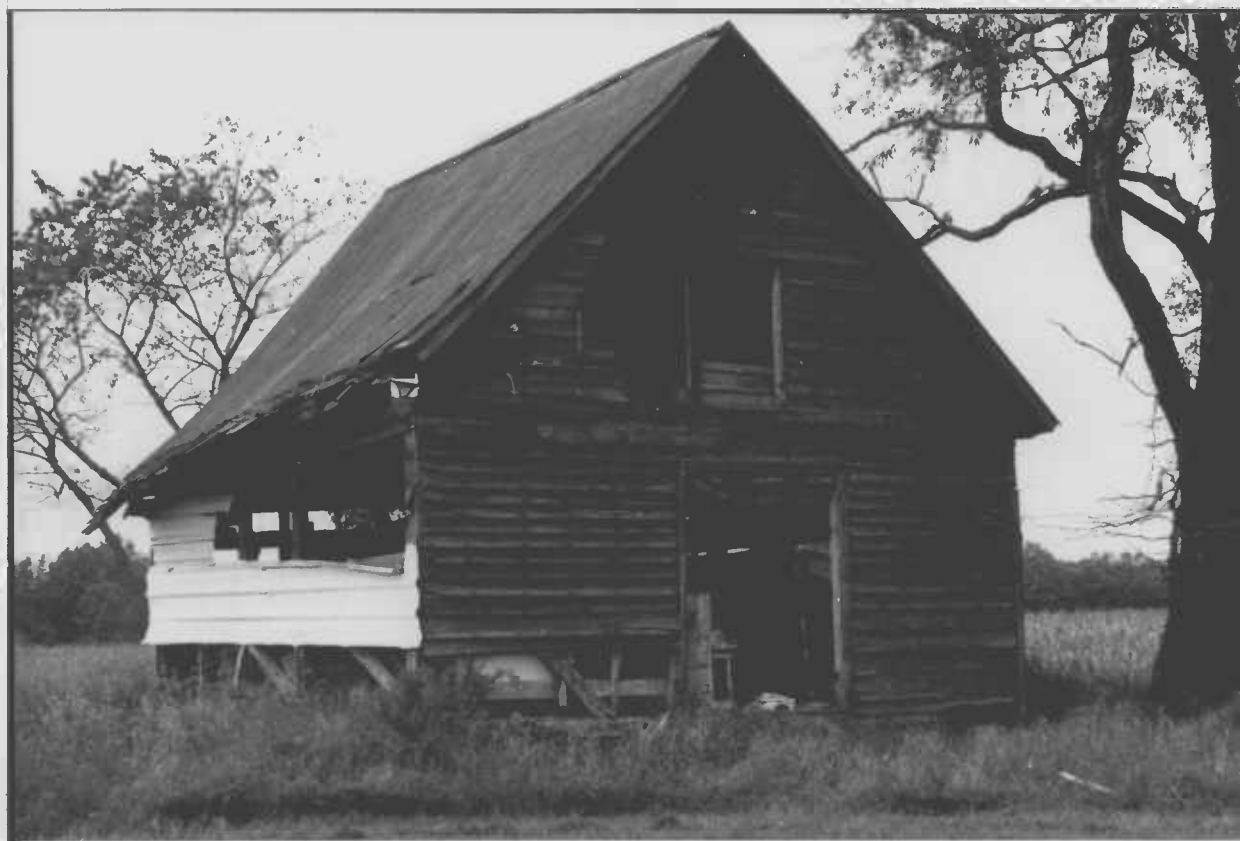
Tarbutton Mill Barn

West of the house exists an early brace framed barn with remnants of original beading siding attached with wrought nails, and other hardware. One original false plate is diagonal, similar to the construction at Wye Mill. The building is in poor condition, but should be salvaged as an existing remainder of this type of barn.
